Permafrost
erosion
along the
Beaufort Sea
coast

Robert L. Lewellen

Geography and Geology Department
University of Denver
Denver, Colorado 80201

Technical Report: Lewellen. (ONR-382:1)

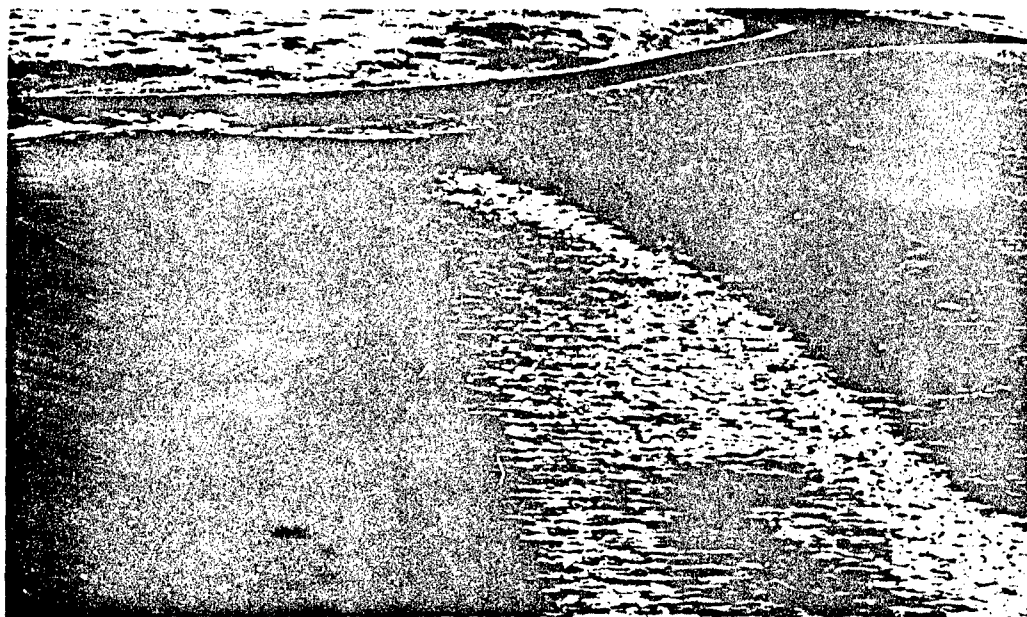
Fig. 9. An aerial oblique photograph showing the large bar of fine sands and silts which have been deposited north of Tekegakrok Point, Elson Lagoon (see Fig. 8). The bar outline is accentuated by the decaying ice. This bar protects the western coastline from Brant Point to Ikpiik. Point Barrow can be seen in the right background of the photograph. The patterns made by the decaying ice are useful in the study of the near shore environments. The photograph was taken 15 June 1967.

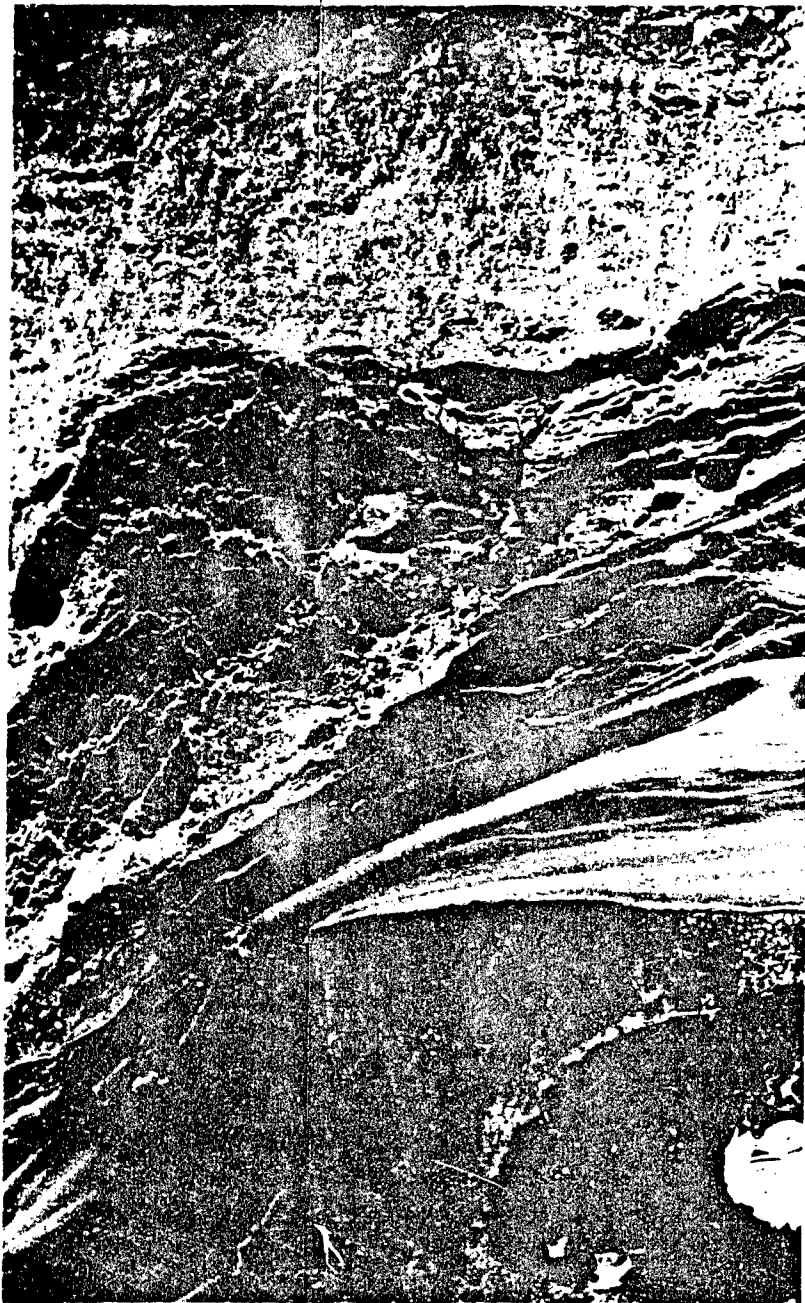
Fig. 18. This aerial photograph illustrates the strands of frazil ice and skim ice which form during the initial phase of the annual freeze-up. The formation of frazil and skim ice stops the erosive wave action. The photograph was taken over Brant Point, Elson Lagoon on 5 September 1956 at a scale of 1/10750.

Fig. 18 is an aerial photograph taken 5 September 1956. It illustrates the strand lines of frazil ice and skim ice which develop in the initial phases of ice formation. The location is Brant Point on the west shore of Elson Lagoon. The strands of ice eliminate wave action and halt thermo-erosional niching. The ice formed after a seven day storm which began on 24 August and ended 1 September 1956. The storm was typically characterized by easterly winds averaging 27 kilometers per hour (17 mph) with the fastest speed at 42 kilometers per hour (26 mph). The air temperatures were -0.6°C to -4.4°C (31° to 24°F) with a trace of snow and sleet.

In the shallow areas around the island, the ice begins to decay during the first part of June. By late September, skim and frazil ice can form which helps to protect the shore from further wave action (Figs. 18 and 34). The 1968 Flaxman Island aerial photography mission was flown on 21 October. The Beaufort Sea was covered with frazil ice. The lagoon between Flaxman Island and the mainland was frozen over by 21 October; approximately three centimeters (one inch) of snow was overlying a few centimeters of ice. The lagoon began to freeze on 23 September. Between 23 September and 21 October westerly winds of 21 kilometers per hour (13 miles per hour) predominated. However, the fastest velocity was about 61 kilometers per hour (38 miles per hour) from the east. Air temperatures were always below freezing for the 29 day period preceding the photography mission. The lowest air temperature was about -16°C (4°F). Freezing degree-days are used to compare the magnitude and duration of freezing air temperatures. The freezing degree-days for one day are computed by subtracting 0°C (32°F) from the average daily air temperature. The accumulation or summation of freezing degree-days for a period of time gives the freezing index for that period. Normally, by 21 October, only 156°C-days (281°F-days) have accumulated for the Flaxman Island area. However, by 21 October 1968, 182°C-days (327°F-days) had accumulated. The greater freezing index for 1968 indicates a more abrupt halt to thermal erosion and a more rapid freeze-up environment for the year.

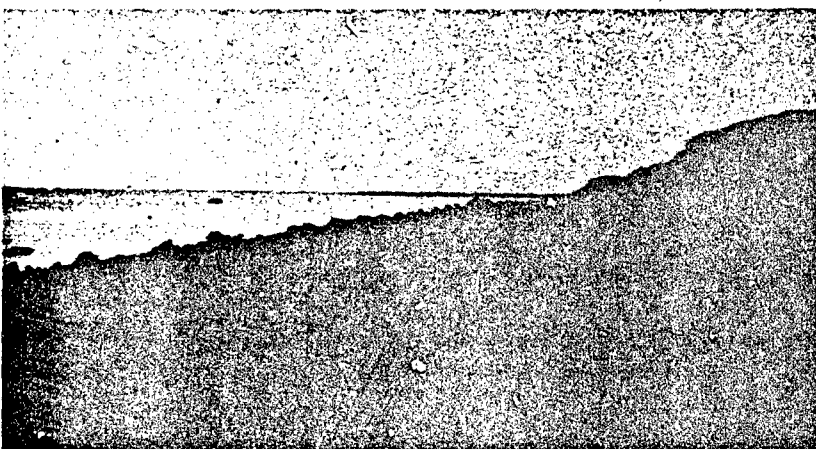
Fig. 21. Fine organic soils slumping in the foreground. Flaxman Formation boulders in the background along the Flaxman Island beach (photograph by Leffingwell, 1919).

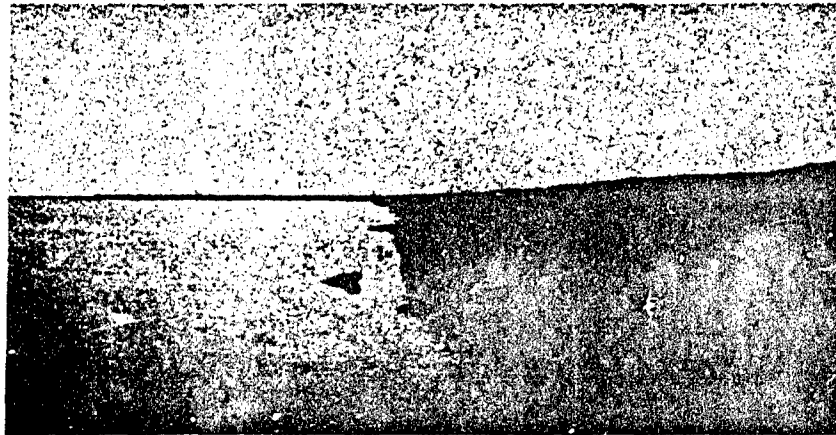
Fig. 23. Flaxman Formation glacial boulders on the beach of the west shore of Flaxman Island (photograph by Leffingwell, 1919, Plate XVI).

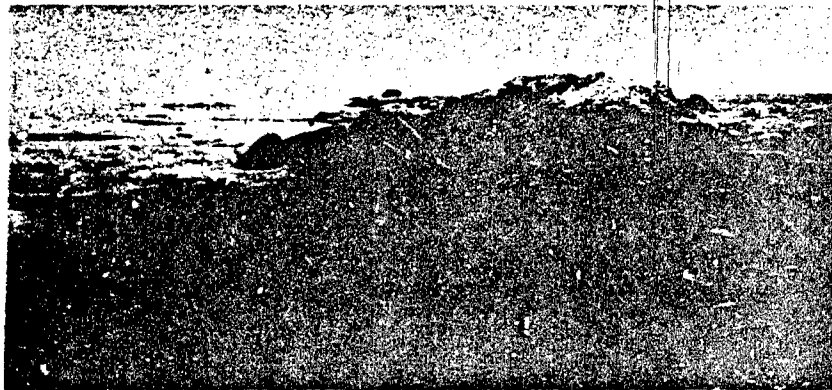
Fig. 24. Mound of sand, gravel, and boulders shoved up by the sea ice as the ice mounts the beach (photograph by Leffingwell, 1919, Plate XXV).

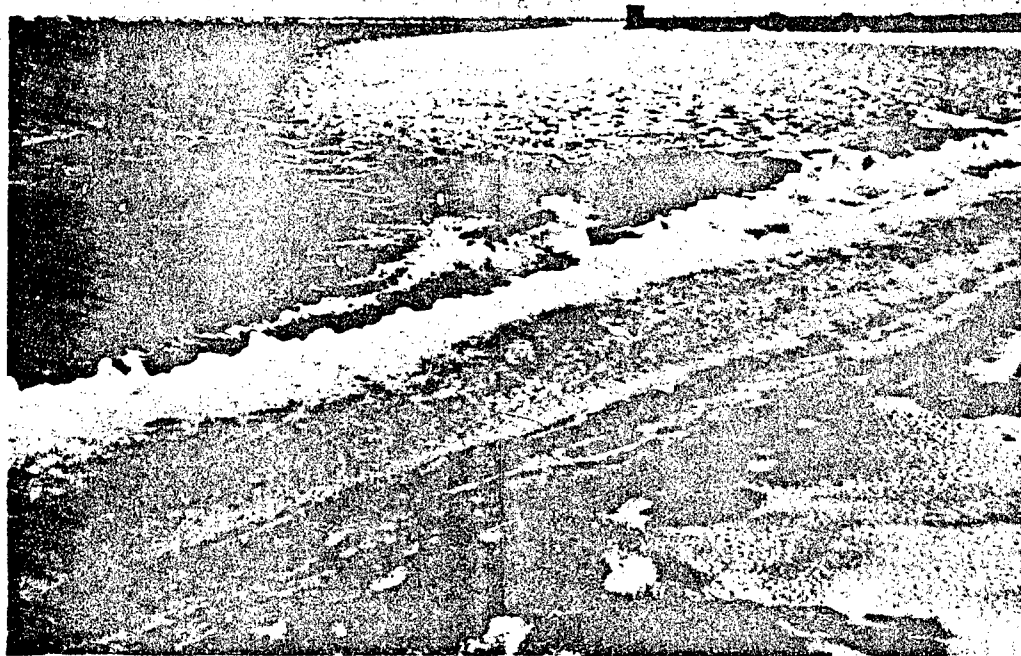
Fig. 34. Frazil ice and freezing spray accumulating along the western shore of Imikpuk Lake, Barrow, Alaska (27 September 1966). This lake is the fresh water supply for the Barrow Naval Camp. The water collection point is marked by the small building in the background of the photograph. Generally, the waves propagate about 10 to 15 meters (33 to 50 feet) into the strands of frazil ice before the waves are completely damped.
